# ELECTRONICS TESTING CENTER TAIWAN

REF. No.: ET94A-11-023

1. Applicant Name : CES Audio Inc.  
Address : No.31-1,Lane 112,Su Wei Road , Panchiao , Taipei ,  
Taiwan,220
2. Description of Device : Sound Projector  
Model No. : SOP-5200D (1 set)  
Date of Receipt : NOV 08,2005
3. Date of Measurement : NOV 11,2005
4. Test Specification : According to Applicant's Spec.  
(IEC60529 Edition 2.1 2001-02)
5. Test Items : See the following sheets
6. Test Condition & Result : See the following sheets

一、Test Item: IP66

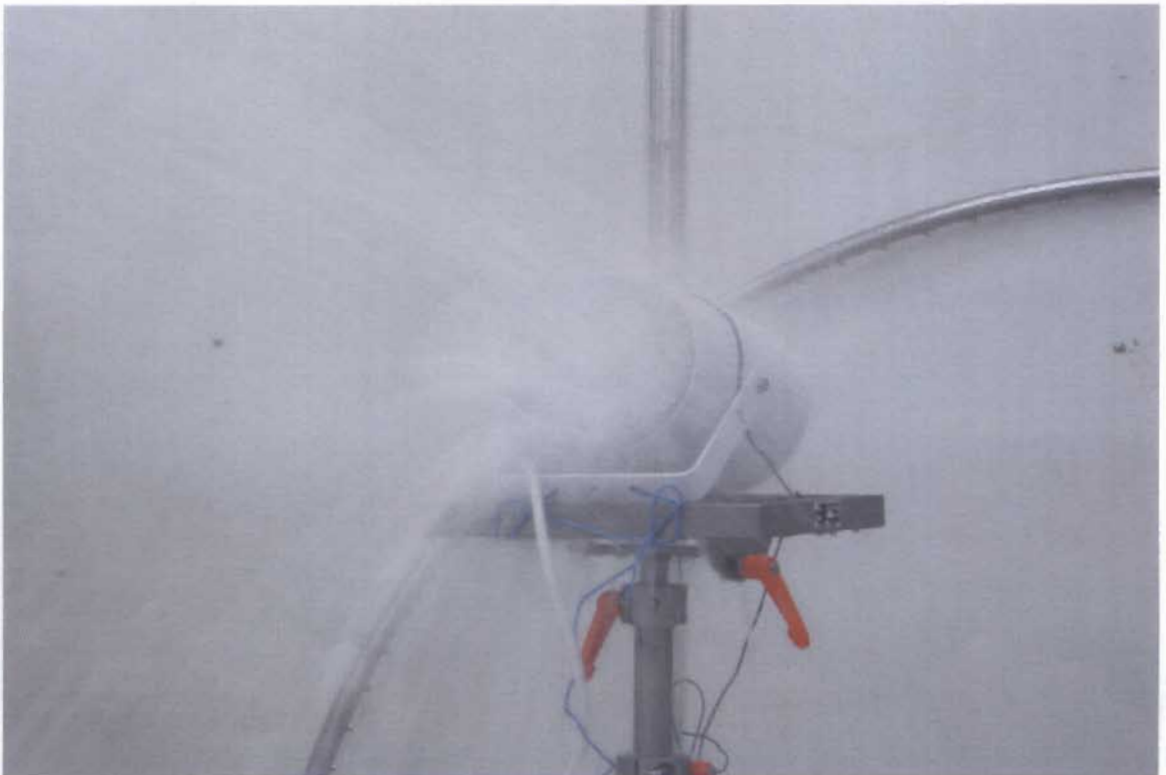
IPX6 Test

- (1) Internal diameter of the nozzle: 12.5 mm.
- (2) Delivery rate: 100 l/min  $\pm 5\%$ .
- (3) Distance from nozzle to enclosure surface: between 2.5 m and 3 m.
- (4) The duration of test is 3 min.

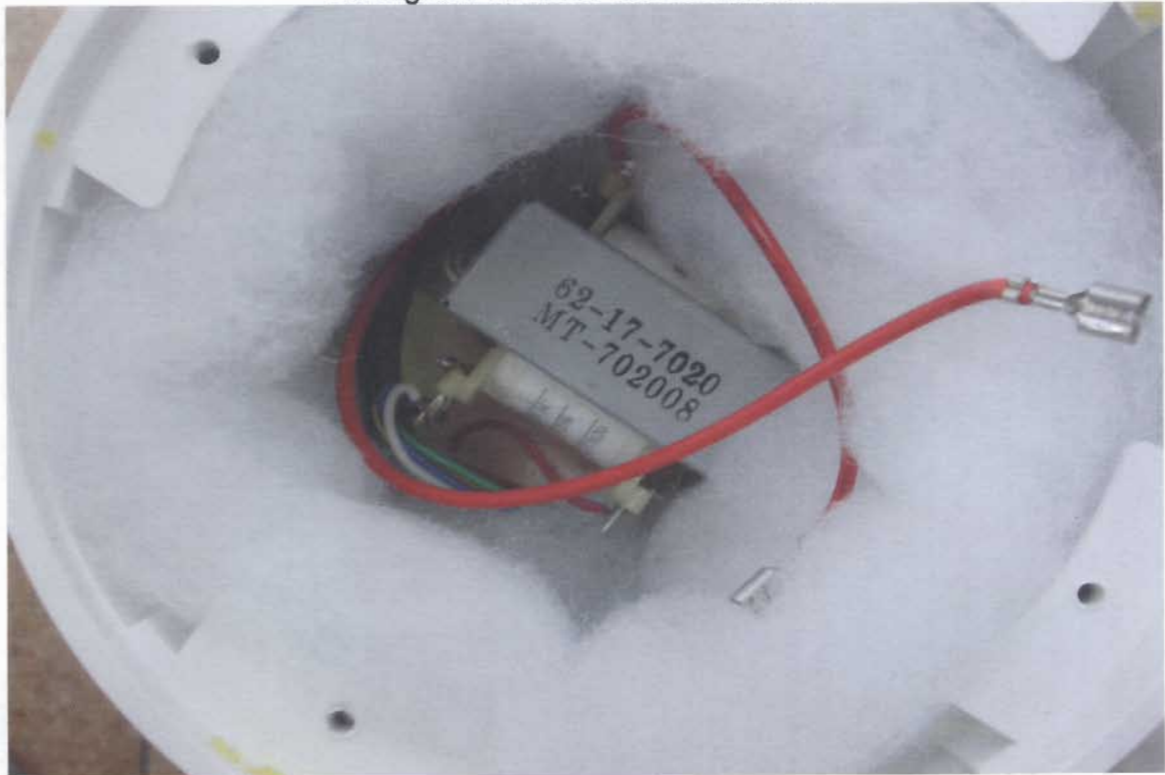
Request/Experiment	Results	Remark
After testing in accordance with appropriate requirements of IEC60529 14.2.6 the enclosure shall be inspected for ingress of water	No ingress of water was found inside.	IPX6

No ingress of water was found inside

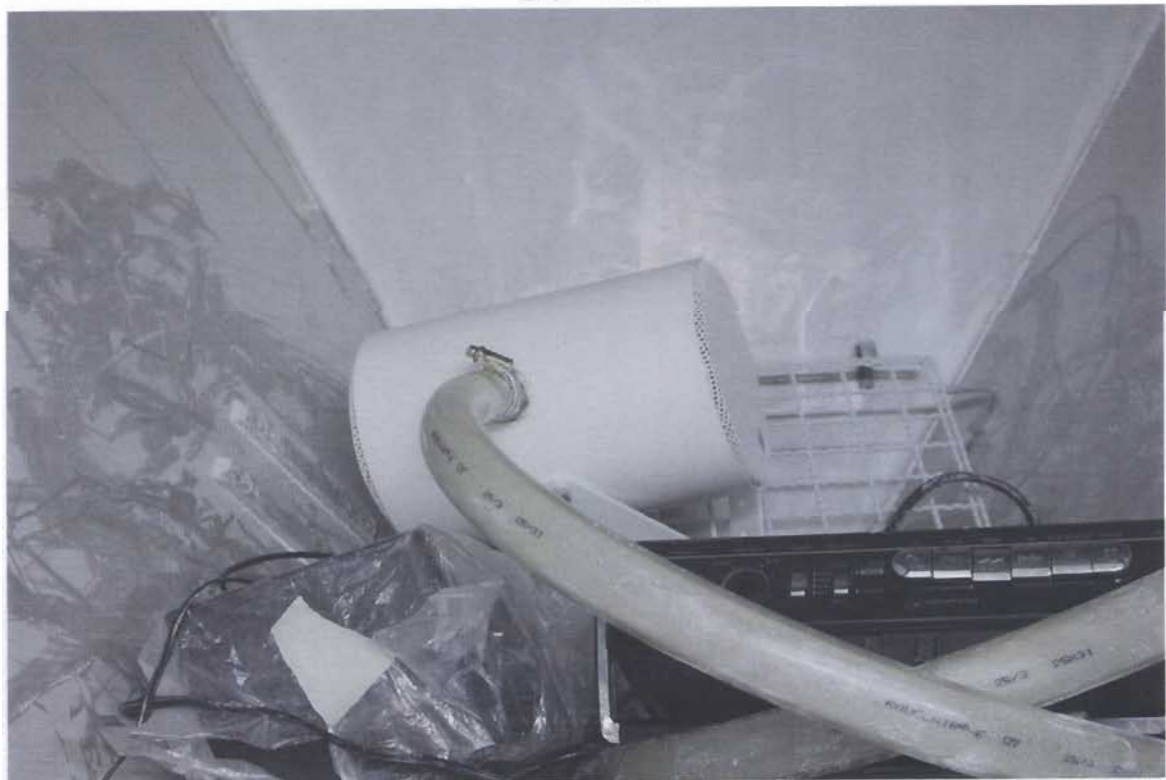
IP6X Test

- (1) Maximum depression of 2kPa(20mbar).
- (2) The total duration of test is 8 hr.

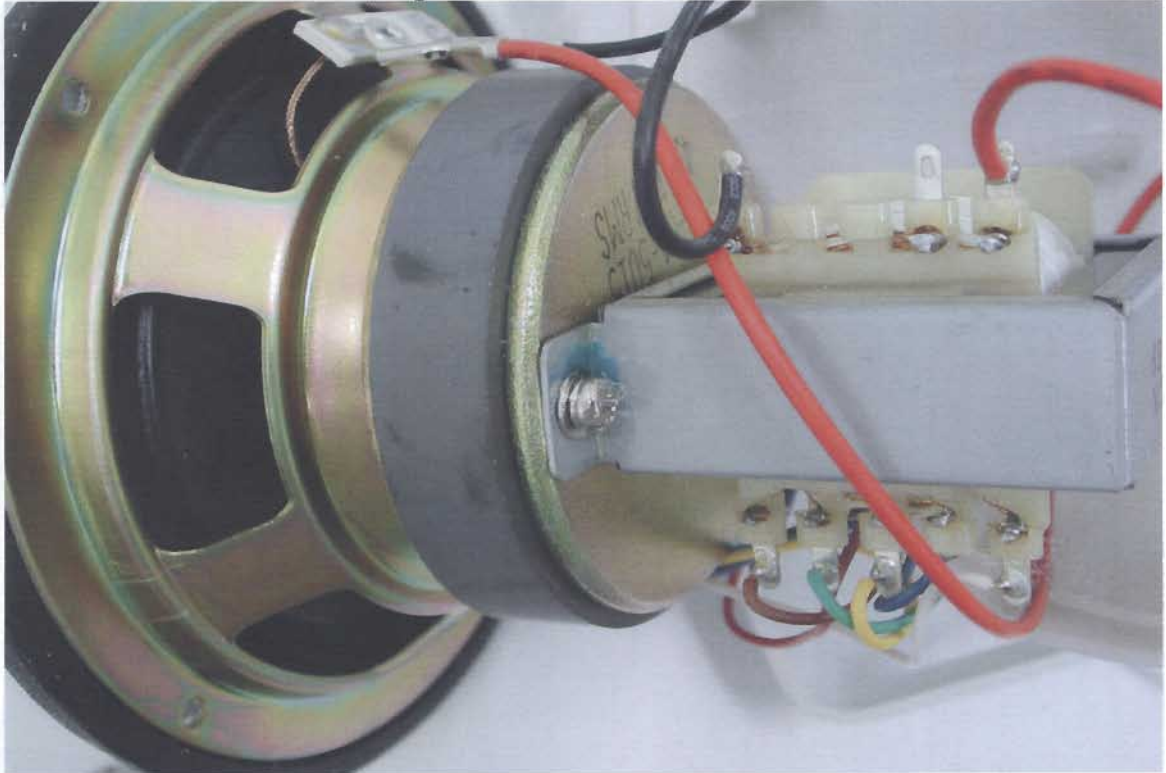
Request/Experiment	Results	Remark
After testing in accordance with appropriate requirements of IEC60529 13.4 and 13.6 the enclosure shall be inspected for ingress of dust.	No ingress of dust was found inside.	IP6X

No ingress of dust was found inside
